## **Home Buyers Report**

**Site Add.:** 39 Galli Way  
 Globulos Square  
 Lower Swell  
 Gloucestershire  
 GL53 3UT

# Plumbing Condition Report

# Central Heating Condition Report

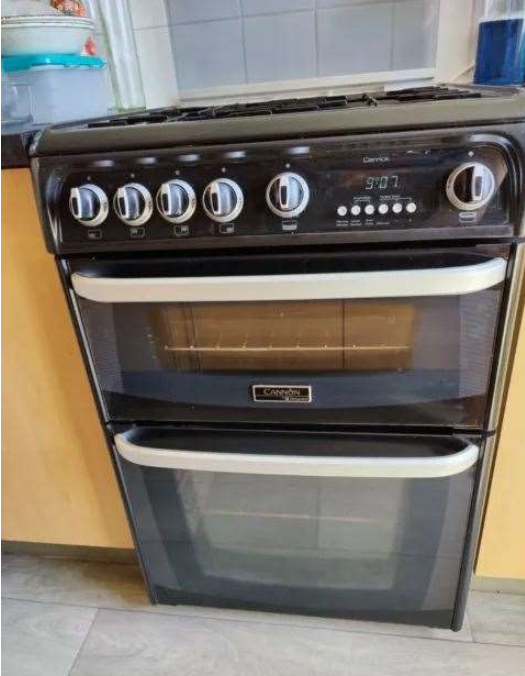
Description: Cooker

Condensing Boiler	Cooker
Location	Kitchen	Kitchen
Make	Vaillant	Cannon
Model #	EcoTec Plus 415	C60GCW
Serial #	2194400100212211300608934N2	701180167
Flue Type	Room Sealed	Flueless
Safety Device	Pass	Pass
Operating Pressure/Gas Rate	15.07 kW (NETT)	20.70 mbar
Ventilation Adequate	Yes	Yes
Flue Flow Test	N/A	N/A
Spillage Test	N/A	N/A
Termination Satisfactory	Yes	N/A
Visual Condition	Pass	Pass
Appliance Serviced	No	No
ID, AR or Advisory situation	N/A	N/A
Gas Council Number	41-694-14	Not Found
Flue Gas Analysis (Ratio)	0.0005	N/A - This appliance is not a boiler
Safe To Use	Yes	Yes
Fuse / Electrical	Safety Isolated	Safety Isolated
Appliance related comments:	Boiler tested on Maximum rate and working as expected.	No engineer comment

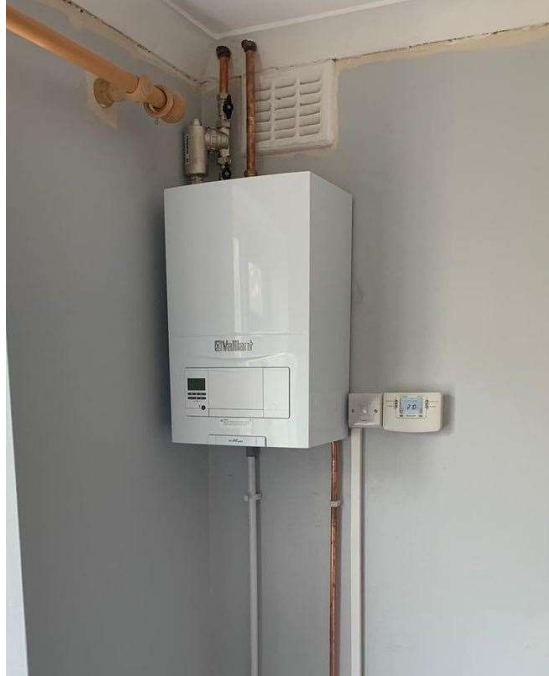
Description: Boiler

Boiler Details				
Boiler- Make	Model:	Approx Age in years	Type of Boiler	Location
Vaillant	EcoTec Plus 4155		Condensing Boiler	Kitchen

Other relevant information: The Vaillant EcoTec Plus 415 VU 156/6-5 has a SAP Seasonal efficiency rating of 89.3%/

The EcoTec Plus 415 is a condensing conventional boiler with a maximum power output of 15.2kw, that uses gas as its fuel source.

**Comments:** Overall installation is in good working order.  
 Full functional check was carried out and all working as required.  
 Every radiator working at the time of inspection  
**\*\*Boiler is fairly new, only 5 years old\*\***  
**\*\*Conservatory is heated by electric panel heaters\*\***  
**\*\*TRV head missing in the dining room (next to conservatory \*\***

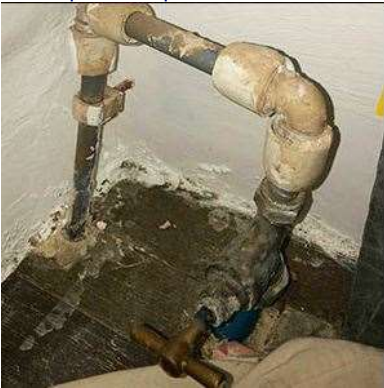
Description: Stopcock

Old/Dated installation present, except for shower room and WC upstairs. 1- Aqualisa power shower does not work - I opened service valves but it made no difference. The pump makes noise, but no flow is pushed from the shower head. It could be jammed or isolated somewhere else and it may be worth asking the current owner if they are aware of the issue. 2. Poor flow from all cold water tap outlets, even main feed. I've checked all visible stopcocks and all seems to be open, however the flow is below average and should be addressed.

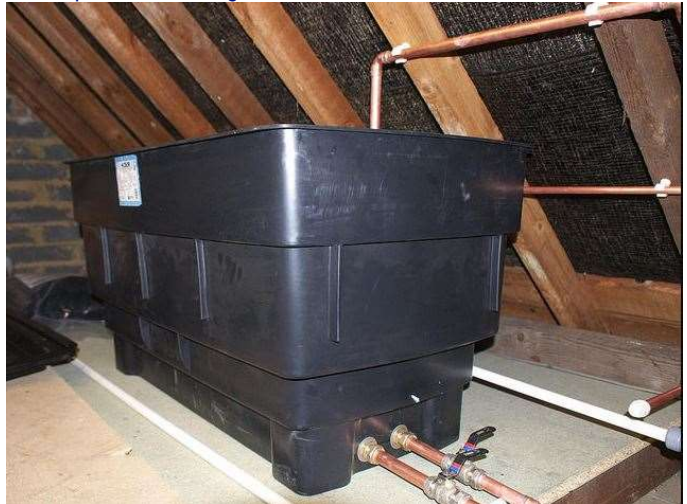
Description: CW Storage Tank

Item tested	Conditon	Comments
Hot Water Storage	Fair	Good sized insulated copper cylinder fitted in the airing cupboard, with no leaks on present pipework.
Operation of immersion elements	Good	Standard 3kw immersion heater fitted as a back up and seems to be working as required.
Cold Water Storage Tank	Good	Tank in the loft seems to be clean inside, has a lid and overall is insulated satisfactorily.
Water flow rate. Main.	Poor	Main feed to kitchen tap only. Flow is okay but normally main flow would be expected to be better. See further comments below.
Low Pressure feed.	Poor	Poor Flow from all Taps, especially cold tap outlets.
Stopcock	Poor	One stopcock found under kitchen sink, but it is letting by. Another one found outside on the drive, however hatch needs to be cleared of soil to access it.
Outside tap.	Good	Functioning and no leaks found, standard check valve fitted.

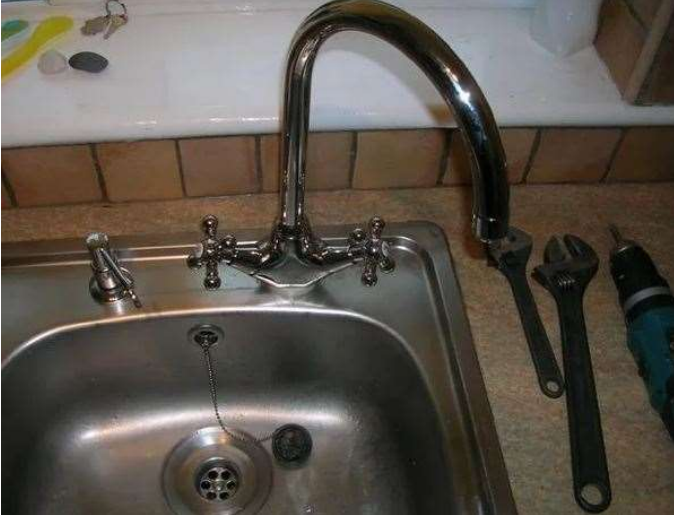
Description: Kitchen Tap

Item tested	Conditon	Comments
Hot Water operates effectively	Good	System was cold at the time of inspection, however temperature rose quickly when demand was introduced
Kitchen sink & plumbing	Poor	There is an old mixing tap installed, which has several small leaks from the washers whilst in use.
Utility room & plumbing	N/A	
Washing machine etc. & plumbing	Good	Connections under the sink in the kitchen and all in good condition.
Dishwasher & plumbing	Fair	Current Dishwasher is a freestanding, table top Dishwasher. If full dishwasher was to be installed, new connections would need to be fitted to existing plumbing.
Ground floor WC & plumbing	Fair	Dated Plumbing but in working order/no leaks.
En suite other	N/A	
Family bath room & Plumbing	Fair	All in working order with no leaks. Seems fairly new, basin okay No bath
Condition of baths & showers	Fair	Aqualisa Power Shower installed, but unable to test. Seems to have been isolated or is jammed. Even after opening feed valves in the loft, the shower is not working.

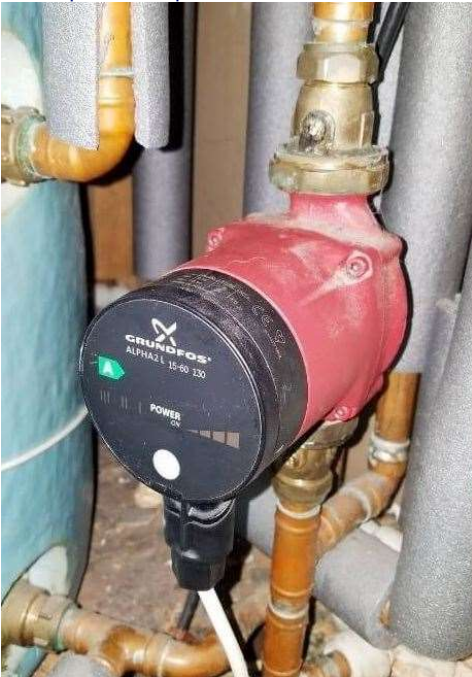
Description: Pump

Item tested	Result	Comments
<b>Boiler Condition</b>	Good	
<b>Central heating pump</b>	Fair	Central heating pump located in the airing cupboard. Pump is aged but in working order.
<b>Heating control and timer</b>	Good	Twin channel (Heating and hot water) programmable time clock fitting in the airing cupboard. All in working order.
<b>Room Thermostats</b>	Good	Basic digital wireless thermostat fitted in the hallway. Fitted new batteries to thermostat as was not working.
<b>Earth bonding to pipe work and boiler</b>	Good	Earth bonding connection to pipework and boiler in place.
<b>Motorised Valve(s)</b>	Fair	S-Plan system installed, two separate Honeywell actuators fitted, one on heating, one for hot water. All working.
<b>Feed/Expansion tank insulation</b>	Fair	Feed tank for heating system is in the loft, water level satisfactory and no leaks.
<b>Fuel Storage Tank and pipe work</b>	N/A	
<b>Discharge/Condense Pipe</b>	Good	Condense run to drain outside, no leaks present.

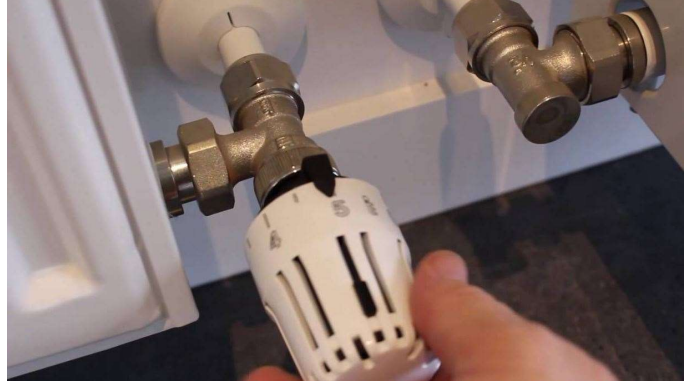
Description: TRV

<b>Drain off cock</b>	Fair	Several drain off points available. One by radiator in downstairs hallway
<b>TRV (Thermostatic Radiator Valves)</b>	Fair	TRV's fitted to all radiators - They seem to be dated and therefore may no longer be accurate. Upgrade recommended
